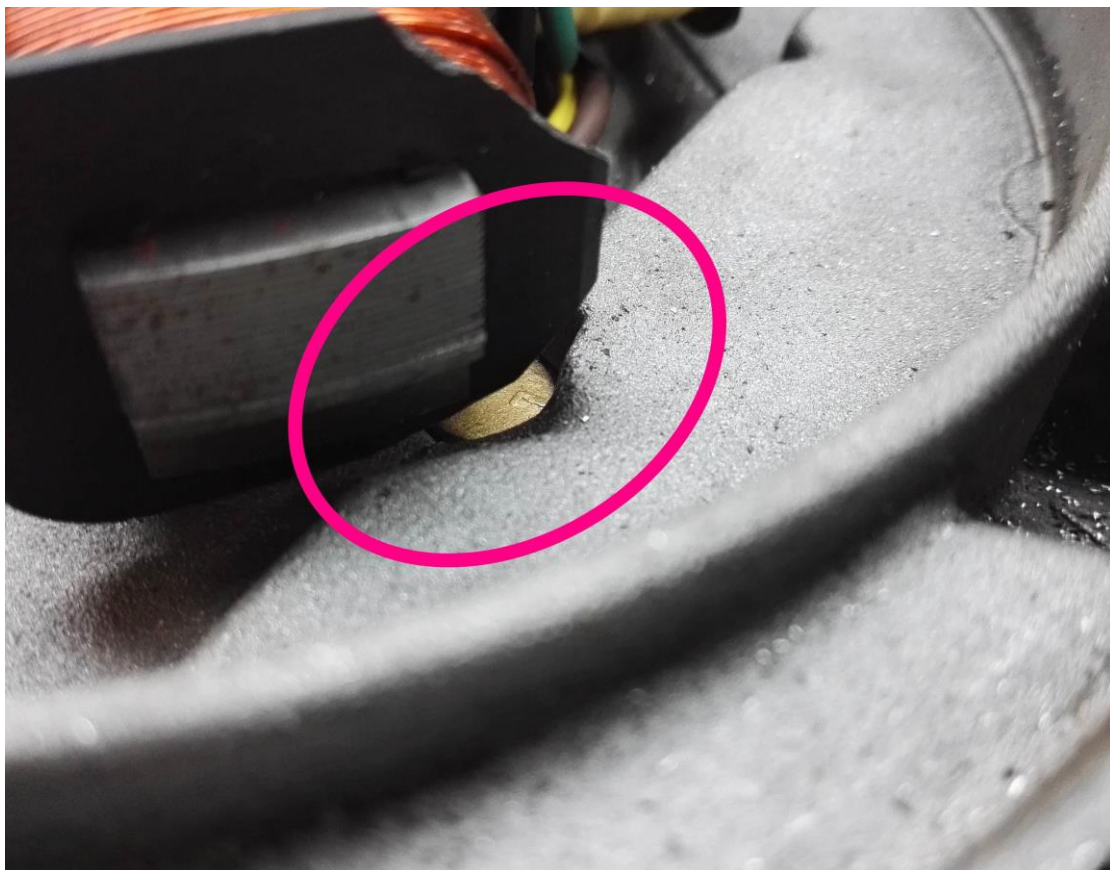
Modification of the coil's plastic, because it touch on the carter. Beware to not damage the coil wire winding.
